Entrance Channel 2011 Bathymetry & Athena Washprobes

PLATE 4: CHARLESTON HARBOR ENTRANCE CHANNEL WASHPROBE LOCATION MAP & REFUSAL DEPTH

EXPLORATION BY ATHENA TECHNOLOGIES

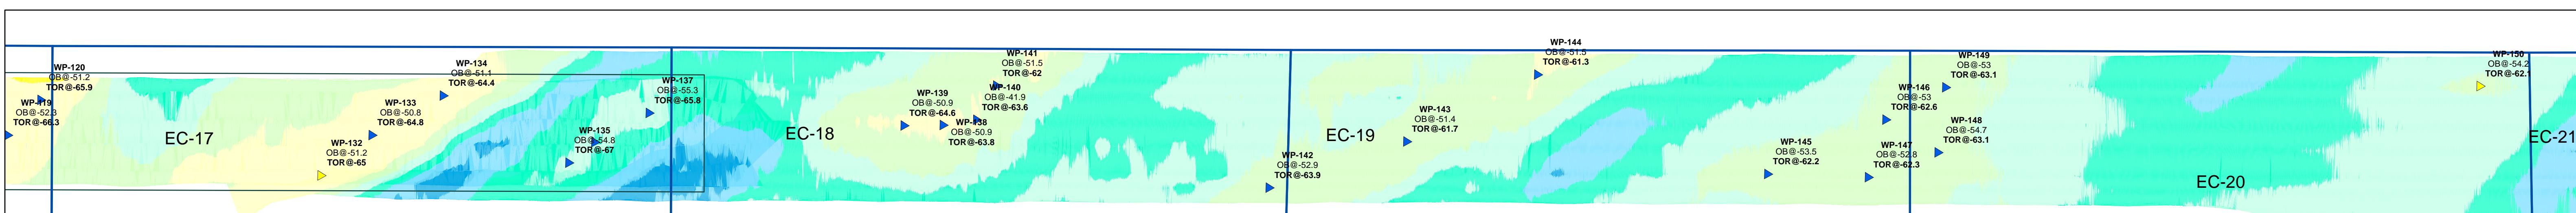
Entrance Channel Sub-Sections 2011 Condition Survey		40 - 44	56 - 58
Athena 2013 Washprobes	Bathymetry (MLLW)	44 - 46	58 - 60
Refusal within Dredge Prism	25.2 - 30	46 - 48	60 - 65
Below -56 MLLW	30 - 34	48 - 52	65 - 70
No Refusal Encountered	34 - 38	52 - 54	70 - 75
Poss Rock Encountered	38 - 40	54 - 56	
Video

OB = Ocean Bottom
TOR = Top of Refusal
